PROPERTY CONDITION ASSESSMENT
OF
WORLD TRADE CENTER PORTFOLIO

ONE WORLD TRADE CENTER

Re: Due Diligence Physical Condition Survey
World Trade Center
New York, New York

REPORT OF
DUE DILIGENCE PHYSICAL CONDITION SURVEY
WORLD TRADE CENTER

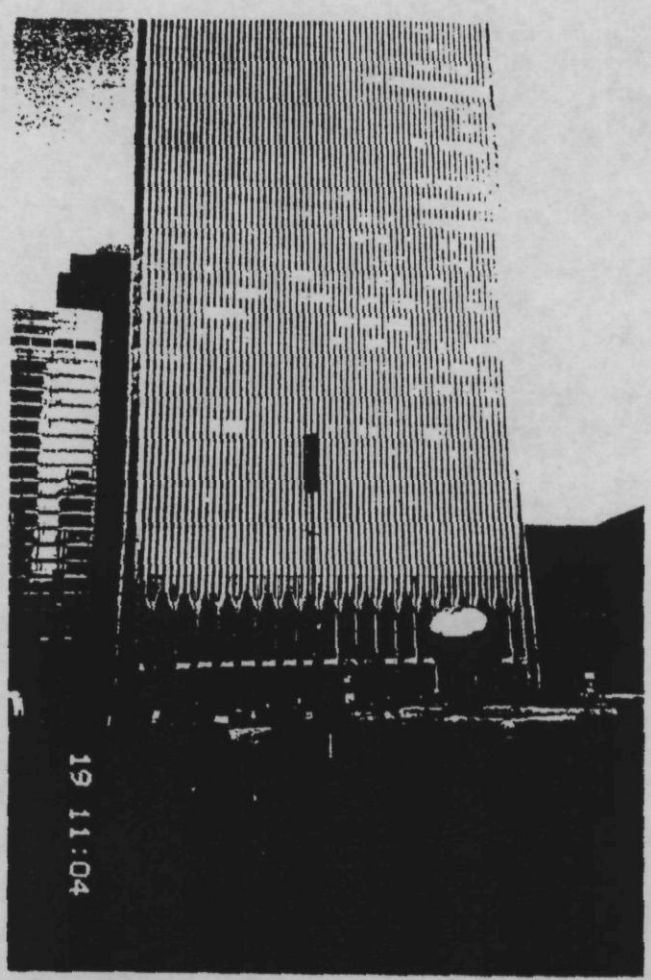
Photograph 1

Front plaza level entrance (east)

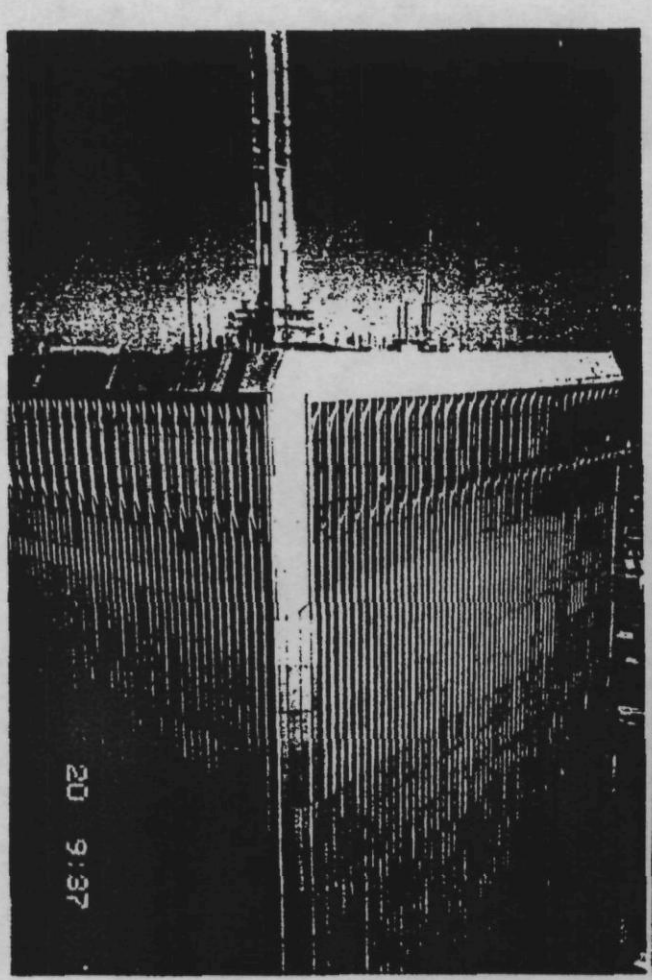
Photograph 3

Rooftop and antenna

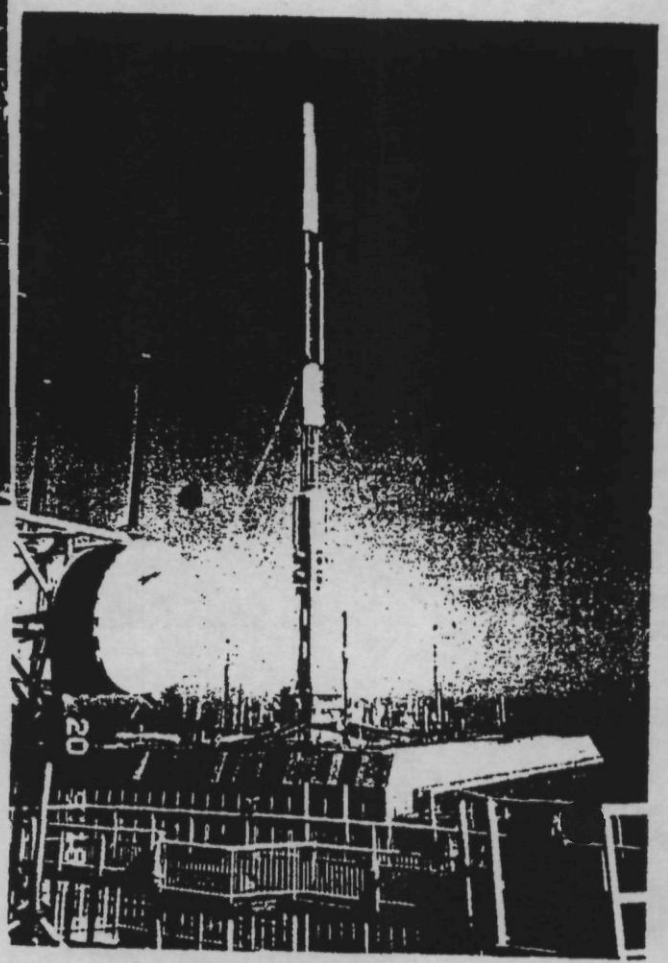
Photograph 4

Antenna

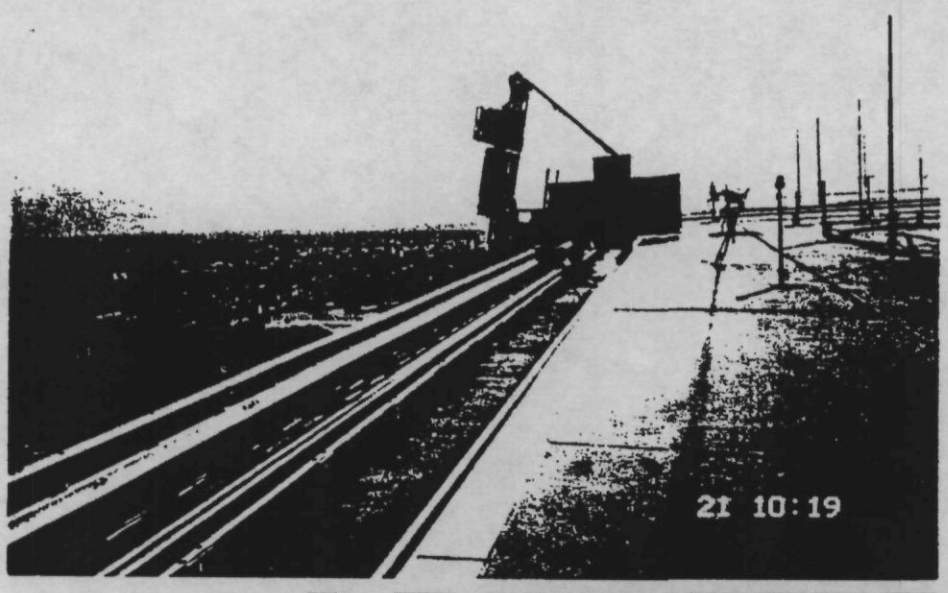
Photograph 6

Typical setback at MER levels

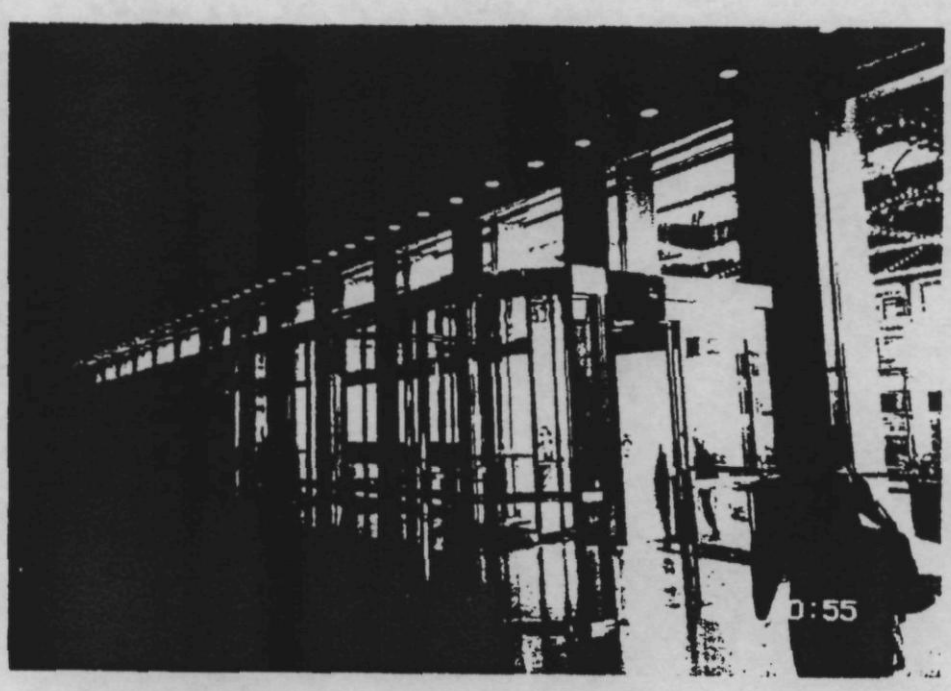
Photograph 10

Lobby entrance and vestibule on West Street

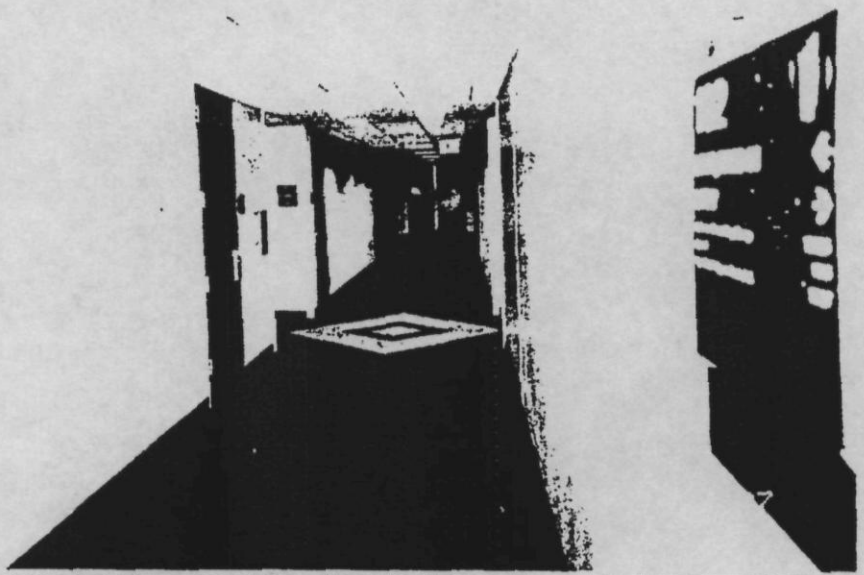
Photograph 12

Typical multi-tenanted floor corridor

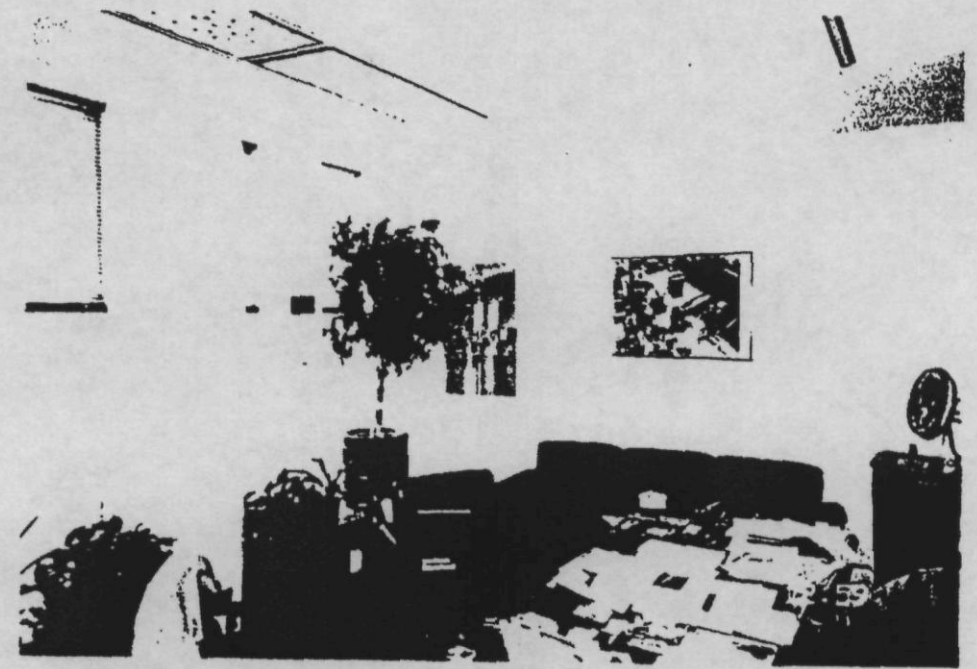
Photograph 14

Typical office

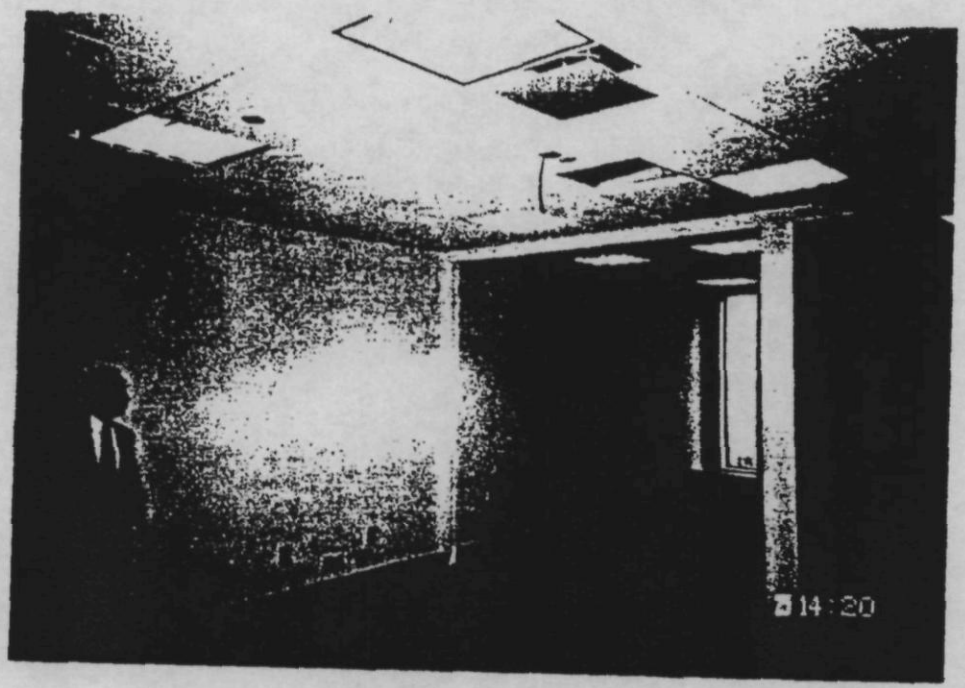
Photograph 15

Vacant space

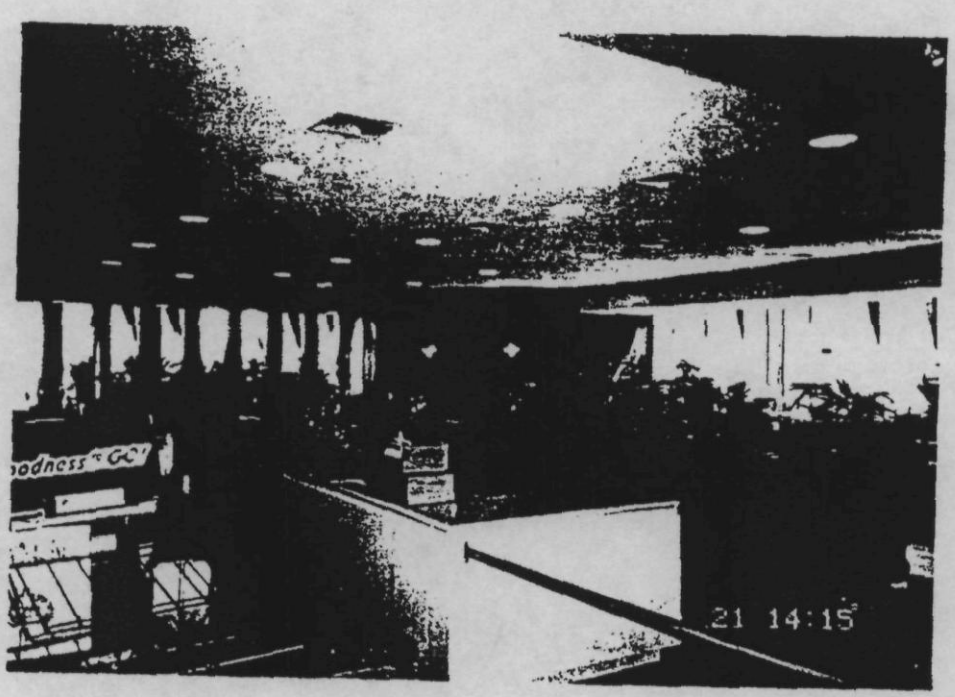
Photograph 17

Port Authority Cafeteria on 43rd floor

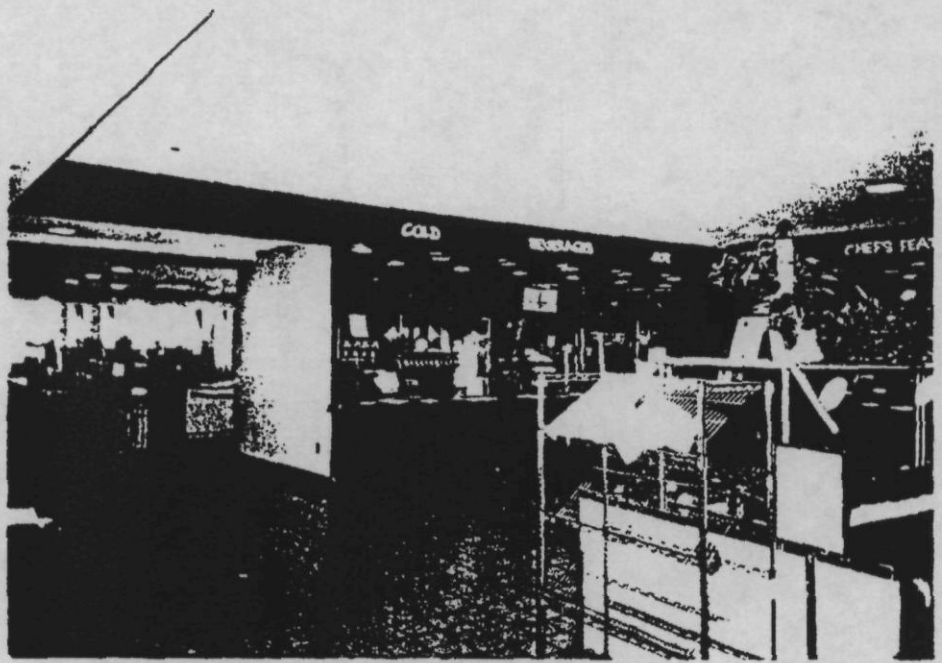
Photograph 18

Port Authority Cafeteria on 43rd floor

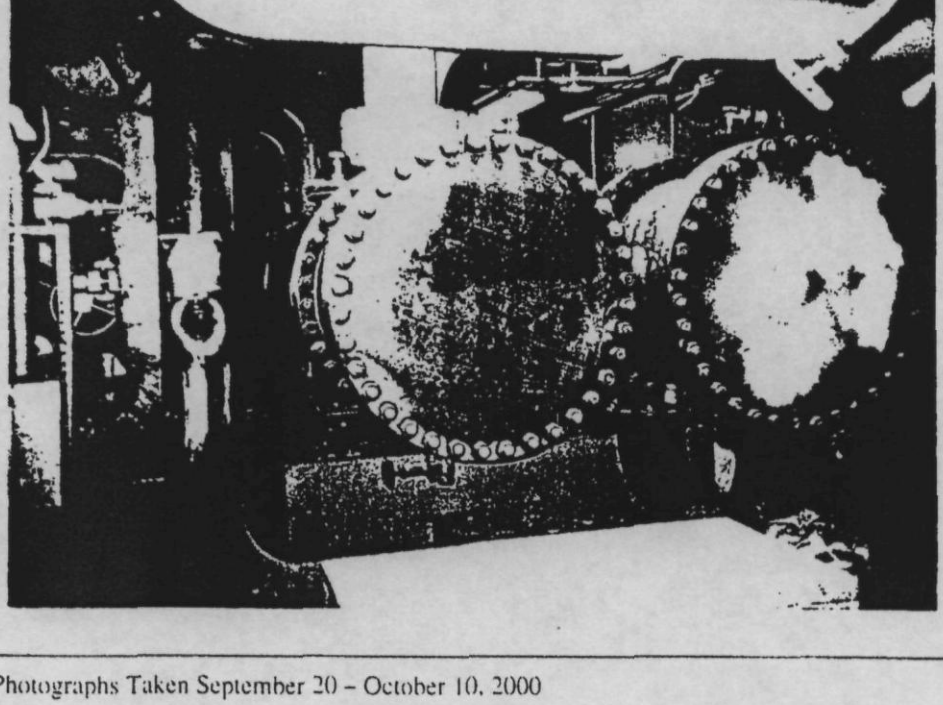
Photograph 2

Condenser water system #2 heat exchangers

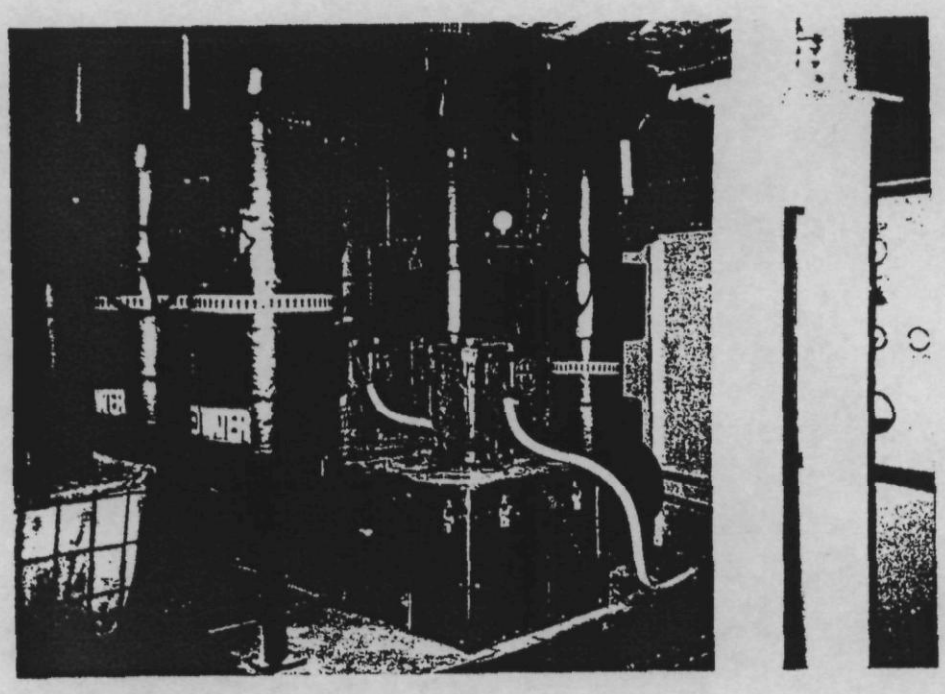
Photograph M4

New freeze protection system chilled water pumps

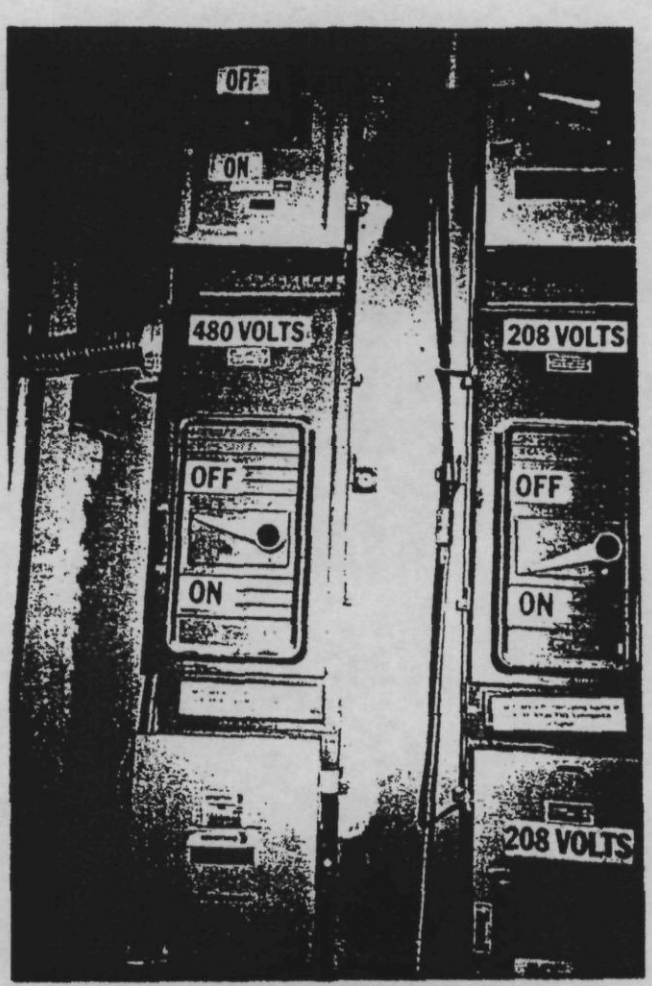
Photograph M5

480 volt and 208 volt electric bus duct risers located in a typical electric closet

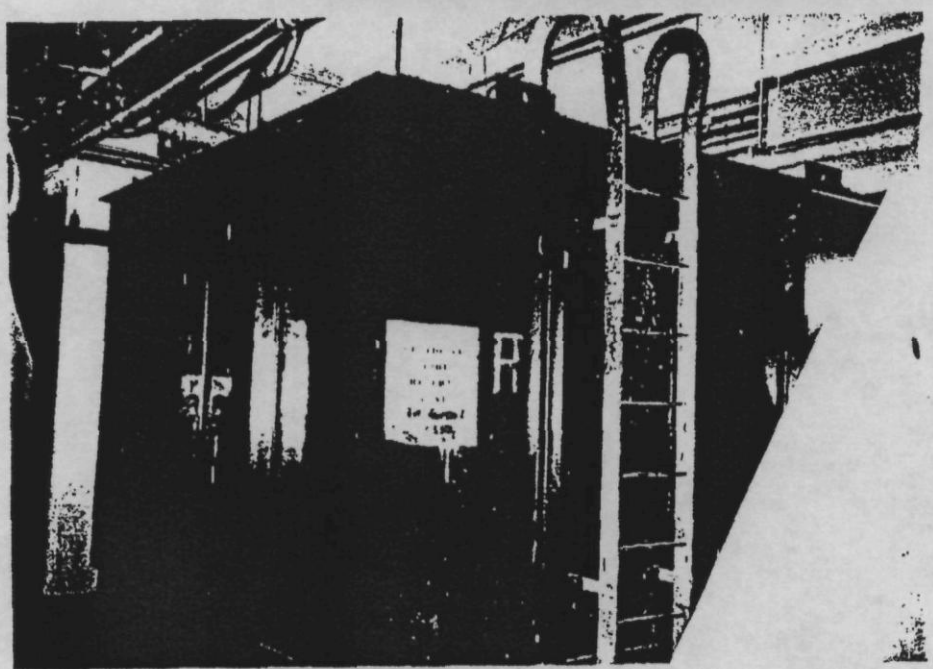
Photograph M6

5,000 gal. standpipe fire reserve tank

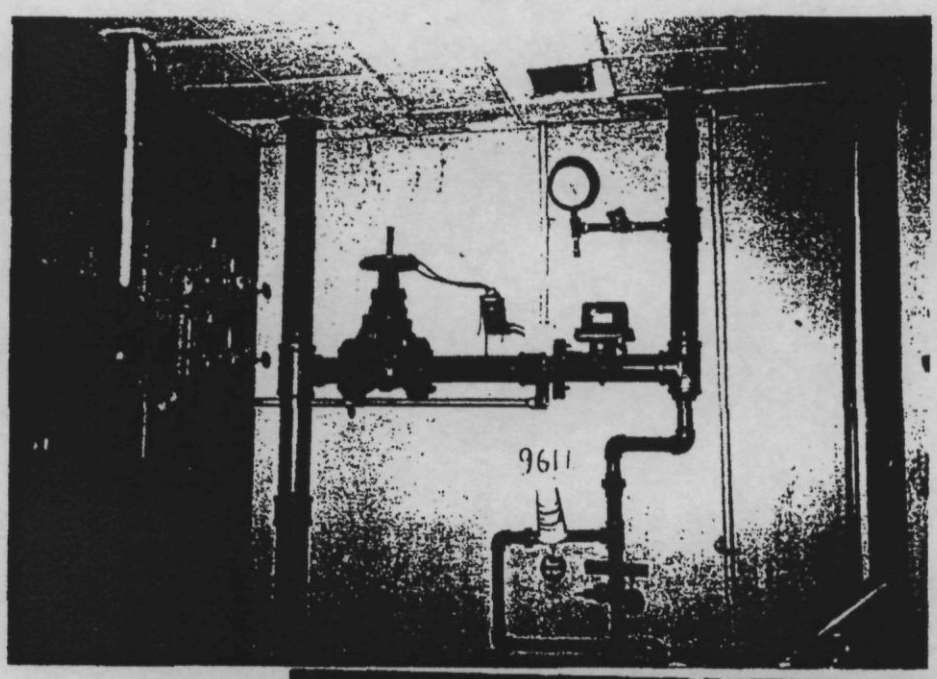
Photograph M7

Typical floor sprinkler control valve room with sprinkler supply line and flow and tamper switches

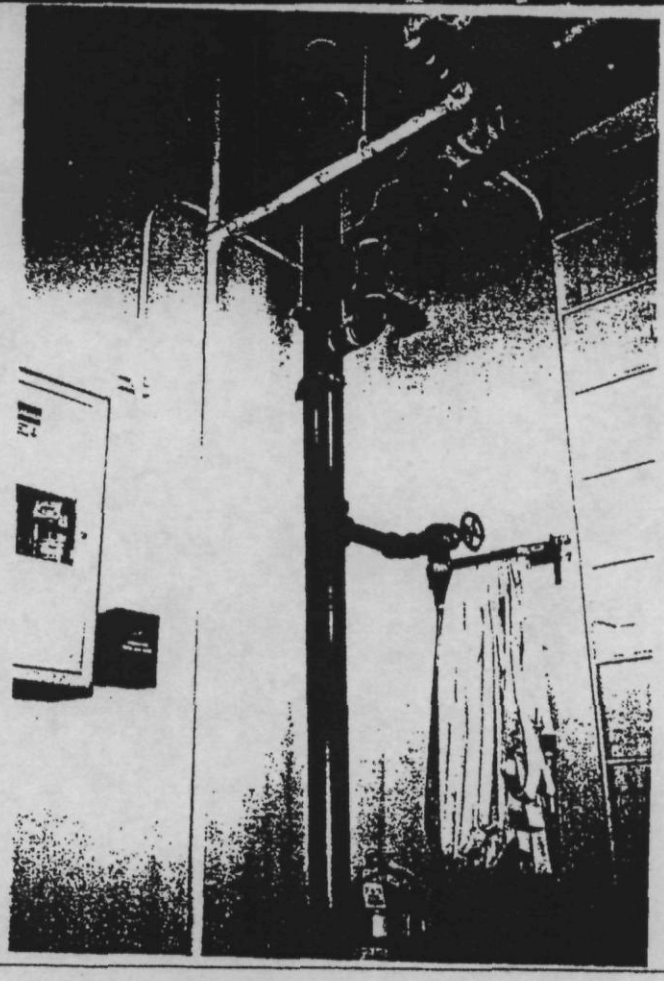
Photograph M8

Standpipe riser with a fire hose rack, and fire extinguisher cabinet located in the stairs

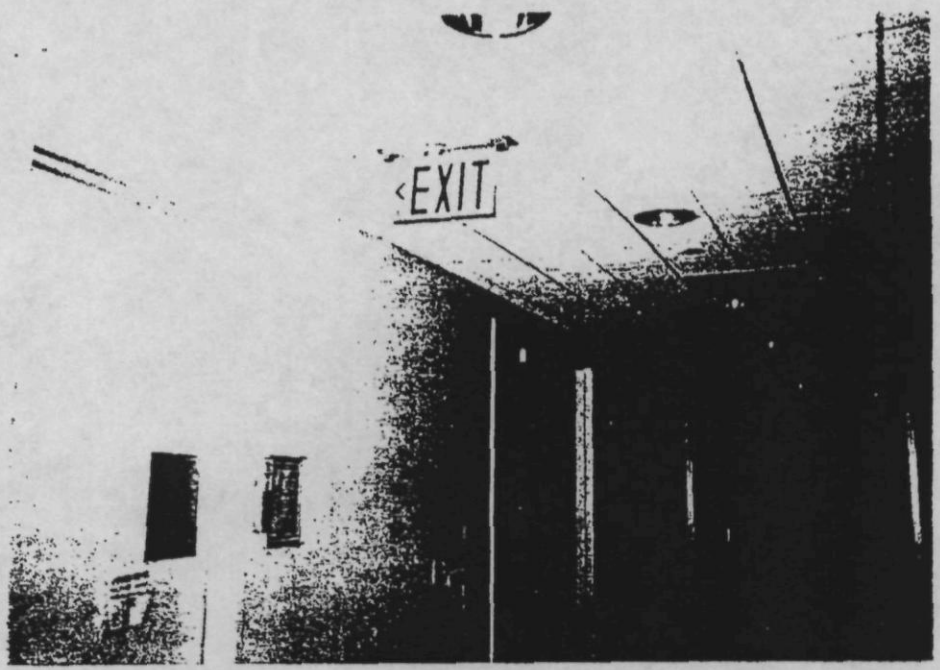
PhotographM9

Typical office floor corridor with an exit sign, manual pull station, fire warden station, and audio/visual alarm

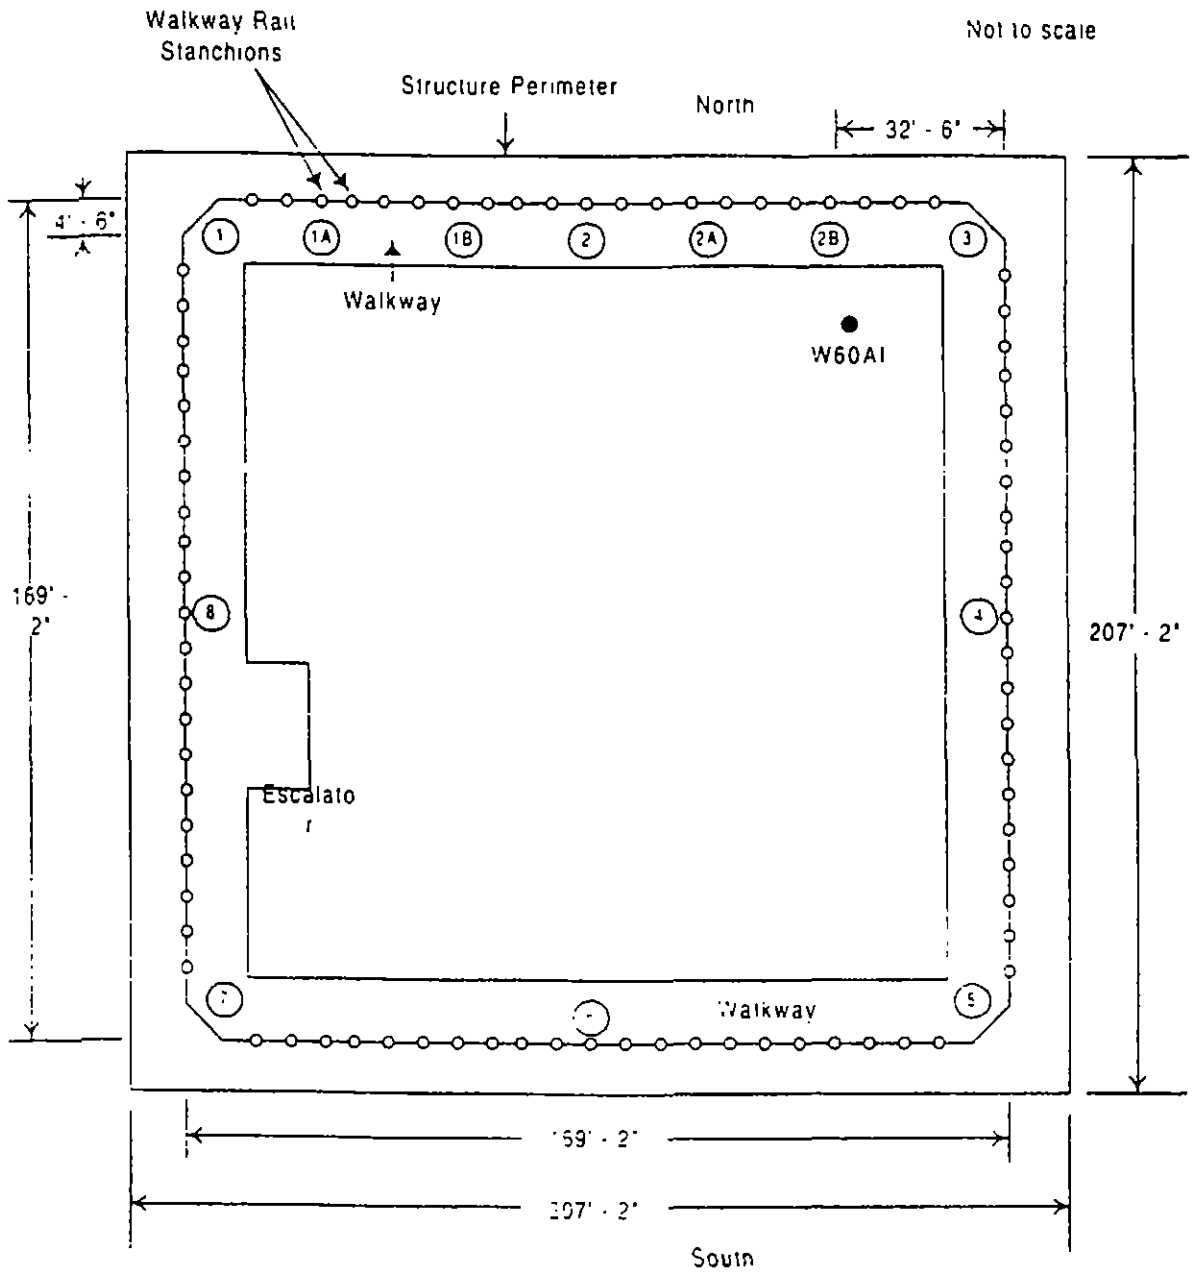
MEASUREMENT LOCATIONS
WORLD TRADE CENTER
SOUTH TOWER ROOFTOP OBSERVATION DECK WALKWAY

With the exception of one of the points under two operating conditions, exposure levels at all of the measured locations comply with the FCC MPE for general population/uncontrolled exposure. When WABC-TV employs its auxiliary antenna and all other stations are in their normal operating mode, the exposure at point 2A is 111.85 percent of the FCC MPE for general population/uncontrolled exposure. The exposure at the same point is 113.00 percent of the FCC MPE for general population/uncontrolled exposure when WWOR-TV and WNET both switch to their auxiliary antennas. Point 2A corresponds to the location identified in the June 18, 1999, WTC2 report where exposure exceeded the MPE for general population/uncontrolled environments when stations were operating in the auxiliary mode. The auxiliary antennas for WABC-TV, WWOR-TV, and WNET are located relatively low on the mast at WTC1. Additionally, WABC-TV, WWOR-TV, and WNET are all high-band VHF stations which employ higher ERPs than the low-band VHF television stations located on WTC1. It is the combination of the WABC-TV, WWOR-TV, and WNET relatively low auxiliary antenna height and higher ERP that results in higher exposure levels at WTC2 for these stations. However, the exposure levels for these stations do not significantly exceed the MPE for general

It is recommended that the December 1998 course of measurements, in which stations or pairs of stations switched to their auxiliary antennas while the remaining stations remained on the air, be repeated. The only change to the December protocol would be to measure the seven points (1, 1A, 1B, 2, 2A, 2B, 3) on the north walkway measured in January 1999 instead of all nine points around the walkway since previous measurements localized the exposure excursion to the north walkway. If exposures in excess of the MPE for general population/uncontrolled exposure are confirmed, then scenarios for reducing power can be explored and tested.

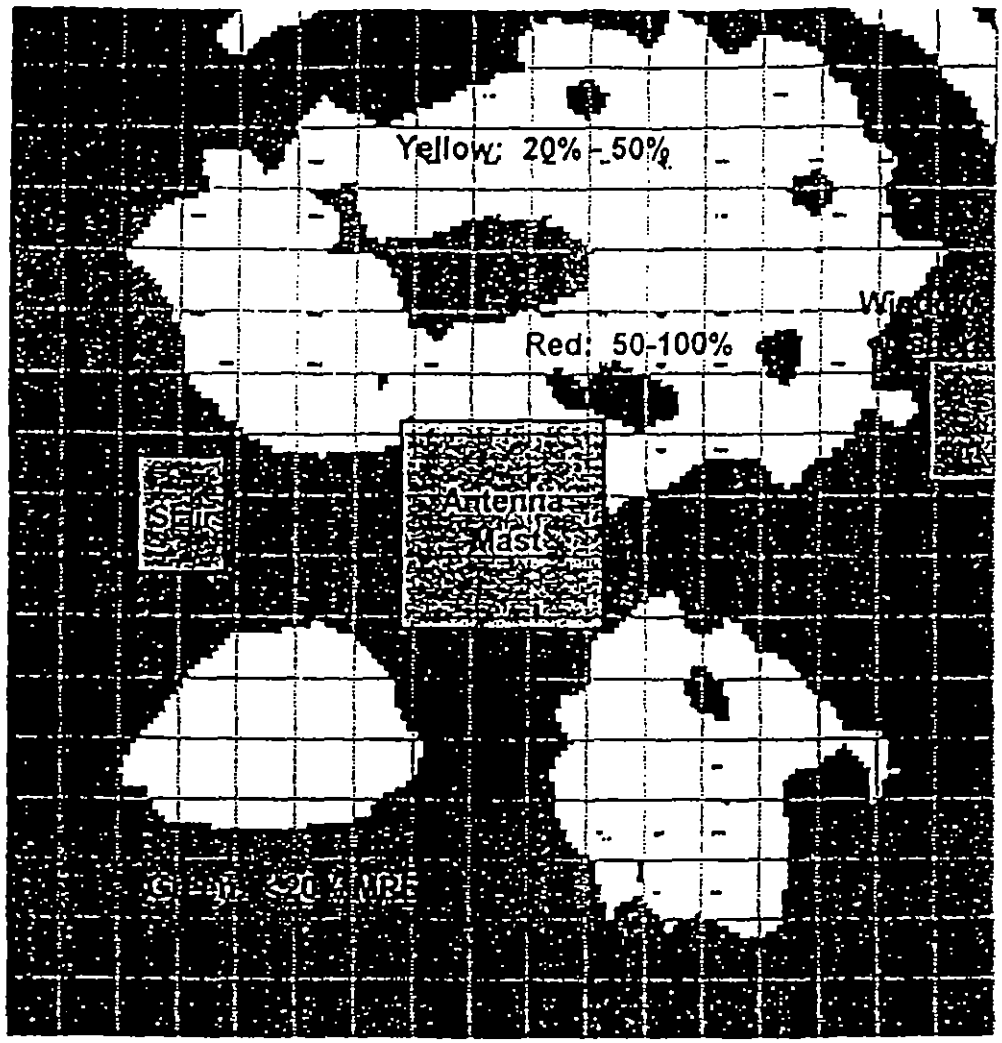
Figure 6. Roof map showing measured ambient RF fields on roof of north tower of World Trade Center during normal broadcast operations with contributions from 72 MHz paging links included Maximum field is 70 2% MPE

Statistical summary of RF Fields on WTC roof (see Figure 6)		
Percent occupational MPE range (%)	Roof area in this range (ft^2)	Percent of roof area in this range (%)
0-20	17070	62.75
21-50	9778	35 94
51-100	350	1 31
>100	0	0 00

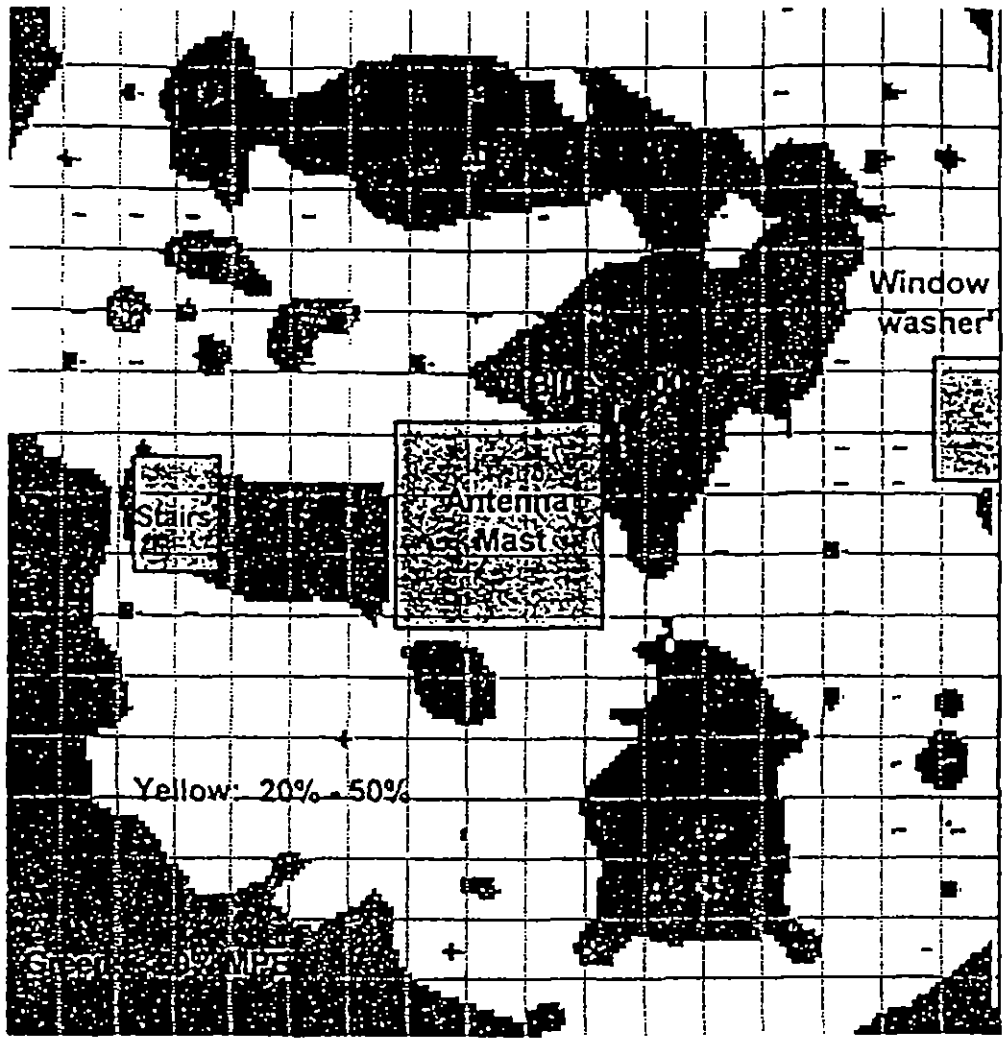
Figure 7. Roof map showing combined RF fields from measured ambient fields of normal broadcasting operations with calculated contribution of all wireless telecommunications antennas. Maximum field is 314 1% MPE

Statistical summary of RF Fields on WTC roof (see Figure 7)		
Percent occupational MPE range (%)	Roof area in this range (ft^2)	Percent of roof area in this range (%)
0-20	4502	16.55
21-50	16454	60.48
51-100	5963	21 92
>100	286	1 05

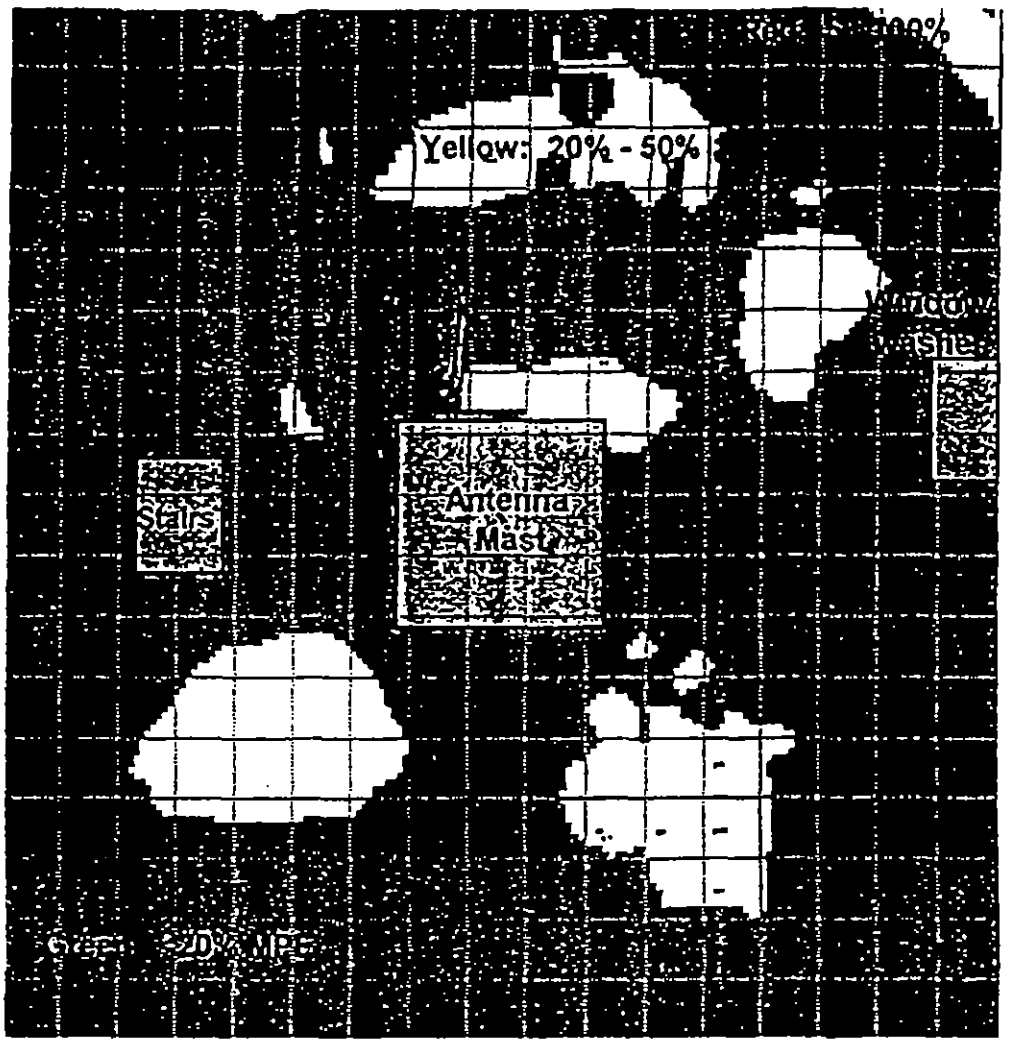
The contribution of the 72 MHz paging link antennas was examined by removing the theoretically calculated fields from those antennas using the RoofView software. This was accomplished by making custom modifications to RoofView which permitted the computation of those fields, as would be performed during a conventional roof analysis, but then subtracting those results for each pixel on the roof. When this process was accomplished, the maximum RF field on the roof was found to decrease from 70.2% (with the 72 MHz pagers included) to 56.6% of the MPE, thereby increasing the amount of roof area subject to fields less than 20% of the MPE. Under this condition, only 15% of the roof area (3,943 square feet) was found to exceed 20% of the MPE. Figure 8 illustrates the resulting colorized roof map of this hypothetical mode of operation.

Figure 8. Roof map of normal broadcast ambient RF fields with contribution of 72 MHz paging links removed via analysis with RoofView Maximum field is 56.6% MPE.

Statistical summary of RF Fields on WTC roof (see Figure 8)		
Percent occupational MPE range (%)	Roof area in this range (ft^2)	Percent of roof area in this range (%)
0-20	23262	85 51
21-50	3937	14 47
51-100	6	0 02
>100	0	0 00

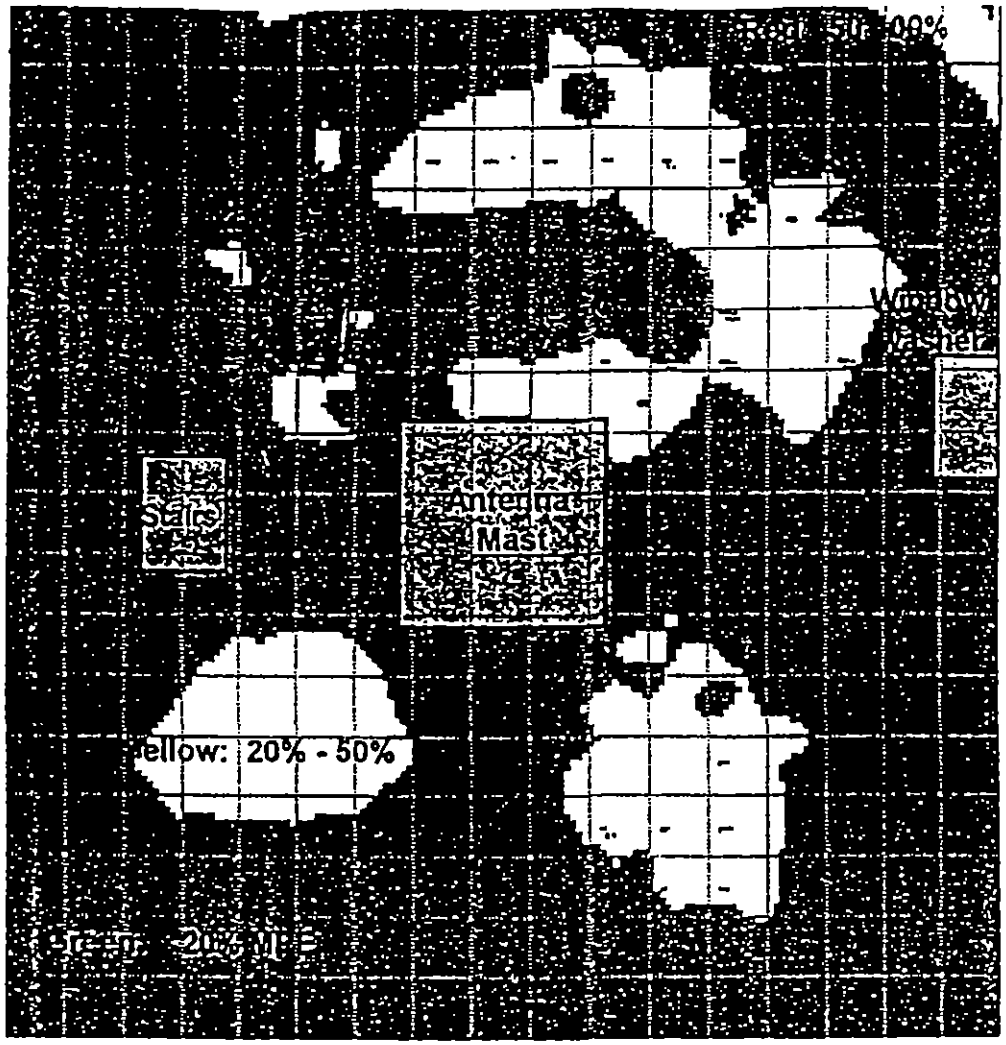
were left as is. The results are shown in Figure 9 and indicate that the maximum RF field level would decrease from 70.2% of the MPE (with the paging links at their present mounting heights) to 57.2% of the MPE. RoofView was first used to subtract the calculated fields from each paging link antenna at each roof pixel, and then to add their contribution back into the ambient, measured broadcast field levels for the condition of being raised to six feet above the roof where applicable.

Figure 9. Roof map of RF fields during normal broadcast operations with calculated effect of raising 72 MHz paging links to 6 feet above roof No other wireless antennas active Maximum field is 57 2% MPE

Statistical summary of RF Fields on WTC roof (see Figure 9)		
Percent occupational MPE range (%)	Roof area in this range (ft^2)	Percent of roof area in this range (%)
0-20	21878	80 42
21-50	5318	19 55
51-100	9	0 03
>100	0	0 00

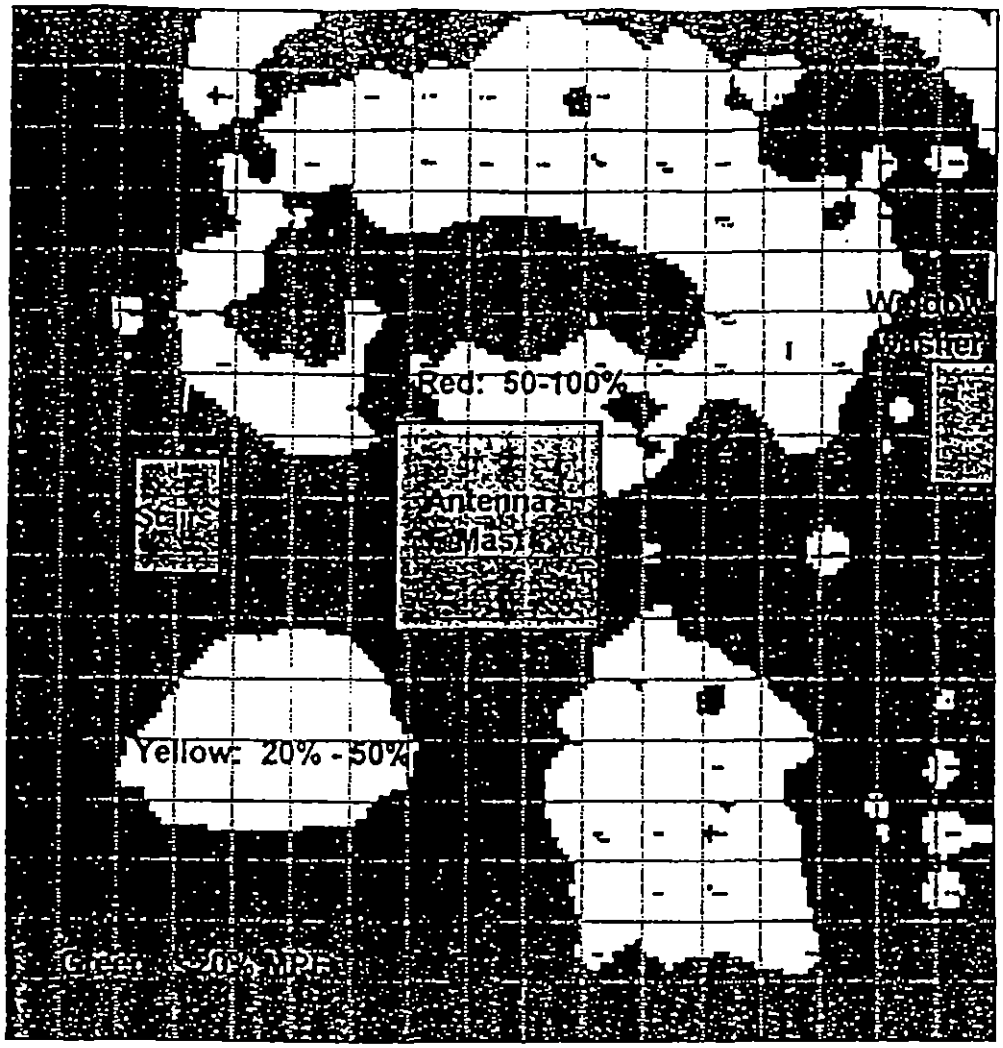
Finally, the result of raising all wireless antennas on the WTC roof to at least six feet was evaluated using RoofView. All antenna mounting heights that were indicated as less than six feet above the roof deck were increased to six feet. Those already mounted greater than six feet above the roof were left as is, similar to the treatment of the 72 MHz paging links discussed above. As expected, this process resulted in significantly lower fields, bringing the projected maximum RF field, found at any place on the roof, down from 314% of the MPE to only 67.2%. Figure 10 illustrates the colorized roof map for this condition. In this case, no area on the roof exceeded 100% of the MPE and the roof area subject to fields greater than the uncontrolled exposure MPE (83.5% before raising the wireless antennas) was reduced to only 32.6%. This substantial reduction in RF field levels supports the common contention that antenna mounting height can play a very significant role in controlling RF fields at roof-top antenna sites.

Figure 10. Roof map of RF fields during normal broadcasting operations with calculated effect of raising all wireless antennas to 6 feet above roof level. Maximum field is 67 2% MPE

Statistical summary of RF Fields on WTC roof (see Figure 10)		
Percent occupational MPE range (%)	Roof area in this range (ft^2)	Percent of roof area in this range (%)
0-20	18325	67.36
21-50	8794	32 32
51-100	86	0 32
>100	0	0 00

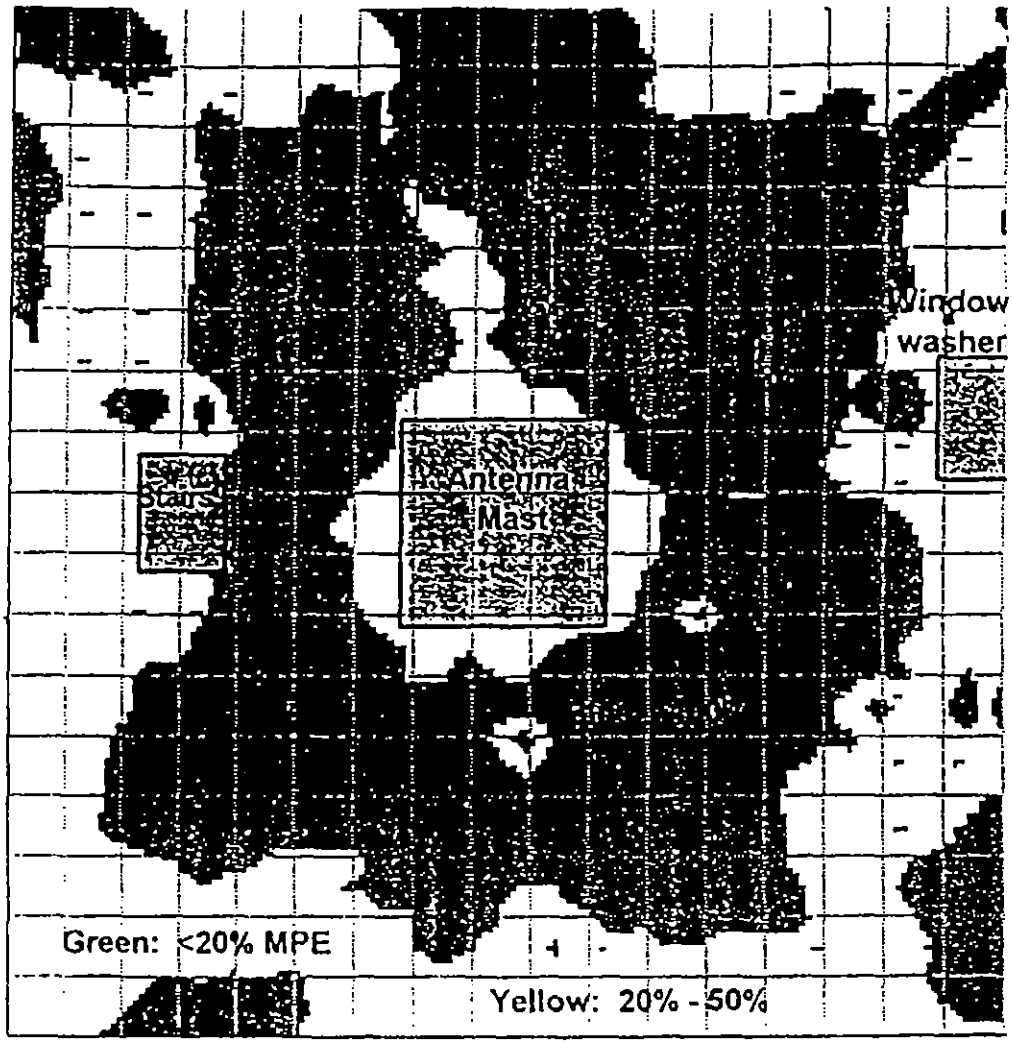
Figure 11. Roof map showing measured ambient RF fields on roof of north tower of World Trade Center during tower maintenance mode of broadcast operations with contributions from 72 MHz paging links included Maximum field is 147.0% MPE.

Statistical summary of RF Fields on WTC roof (see Figure 11)		
Percent occupational MPE range (%)	Roof area in this range (ft^2)	Percent of roof area in this range (%)
0-20	1043	3.83
21-50	11728	43.11
51-100	13298	48.88
>100	1136	4.18

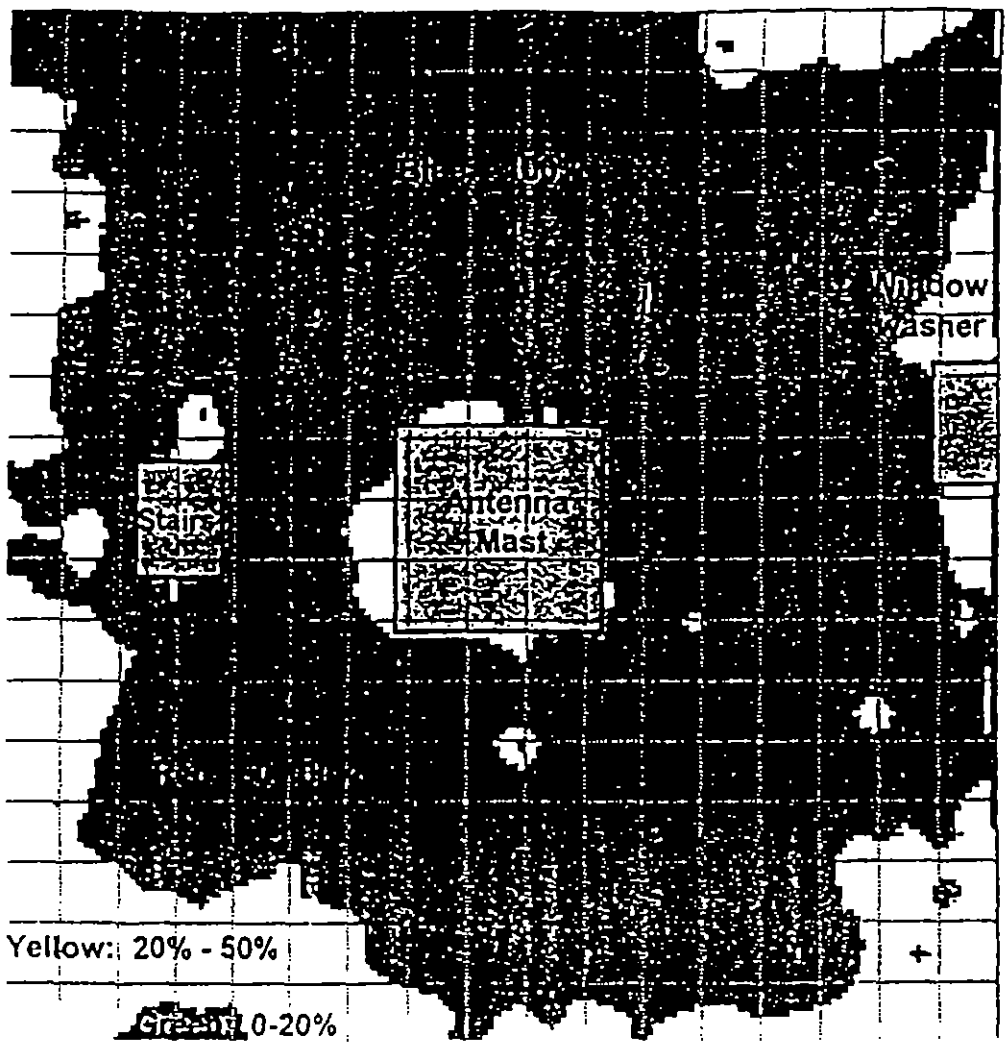
Figure 12. Roof map showing measured ambient RF fields on roof of north tower of World Trade Center during tower maintenance mode of broadcast operations with calculated contributions from all wireless telecommunications antennas included Maximum field is 352% MPE

Statistical summary of RF Fields on WTC roof (see Figure 12)		
Percent occupational MPE range (%)	Roof area in this range (ft^2)	Percent of roof area in this range (%)
0-20	130	0.48
21-50	5695	20.93
51-100	16891	62.09
>100	4489	16.50
